# Hydrographic Survey of North Padre Island Canals

Performed by Island Hydrographic, LLC.  
For Padre Island Property Owners Association

CANAL CONDITION SURVEY  
CUTLASS & BOUNTY CANAL

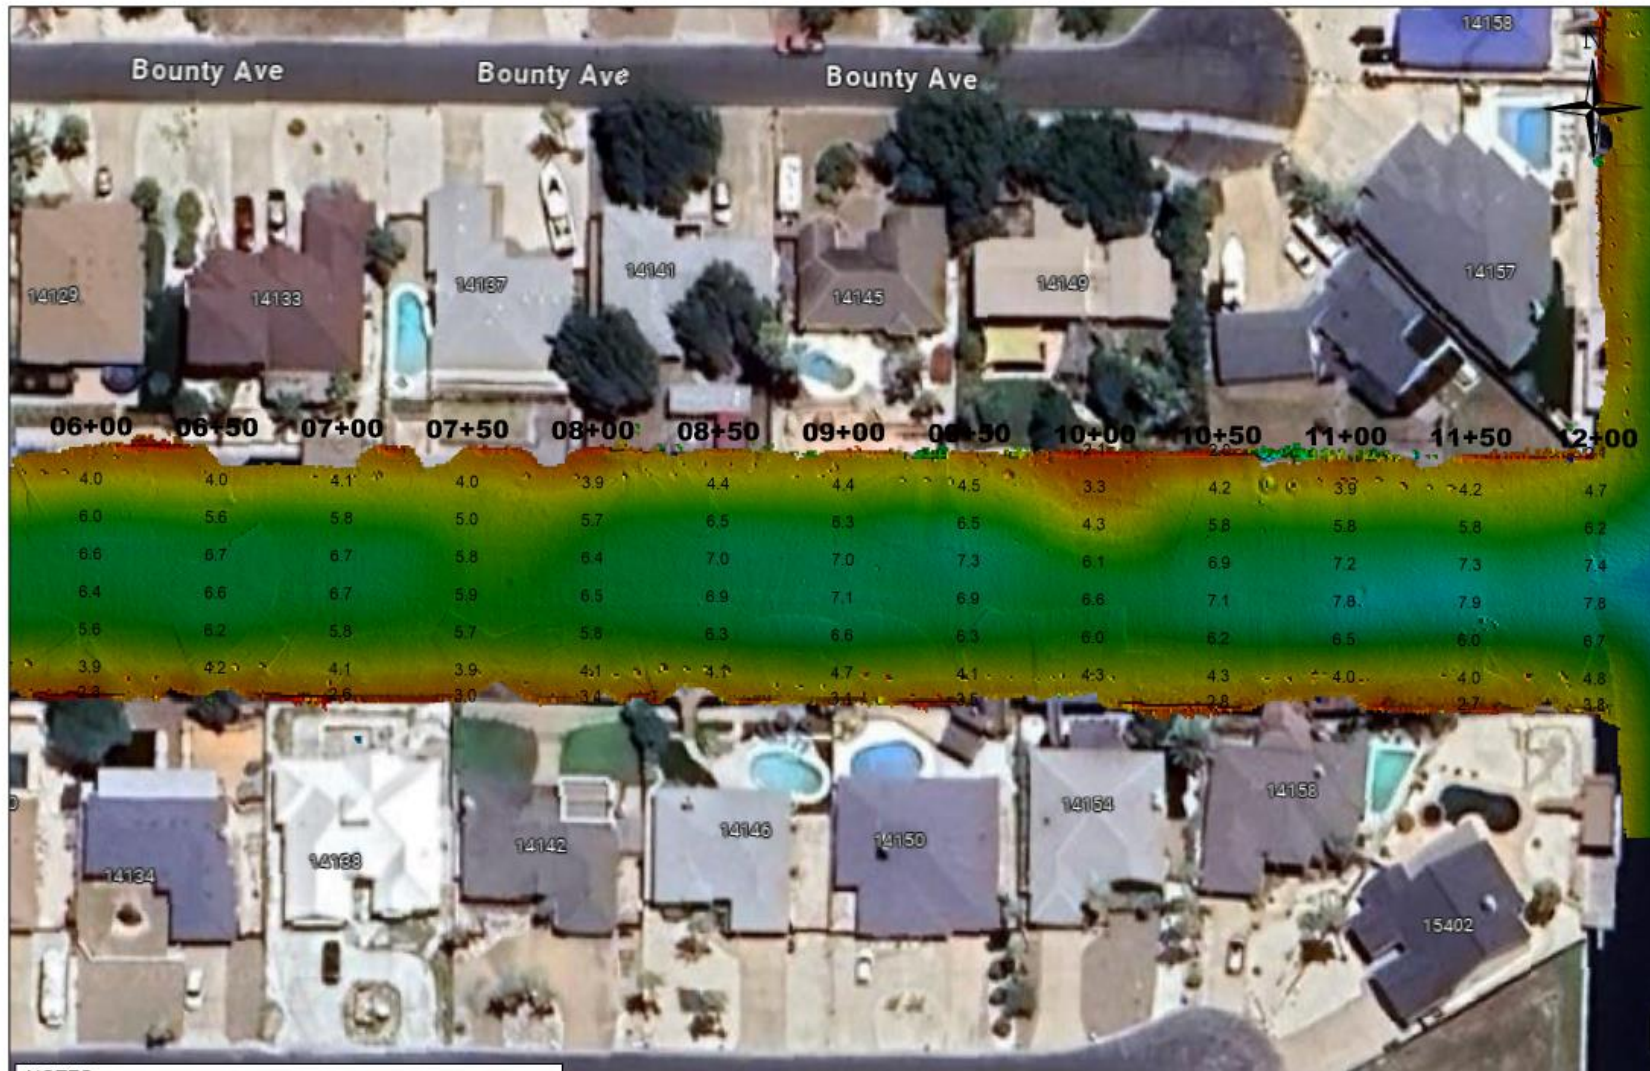
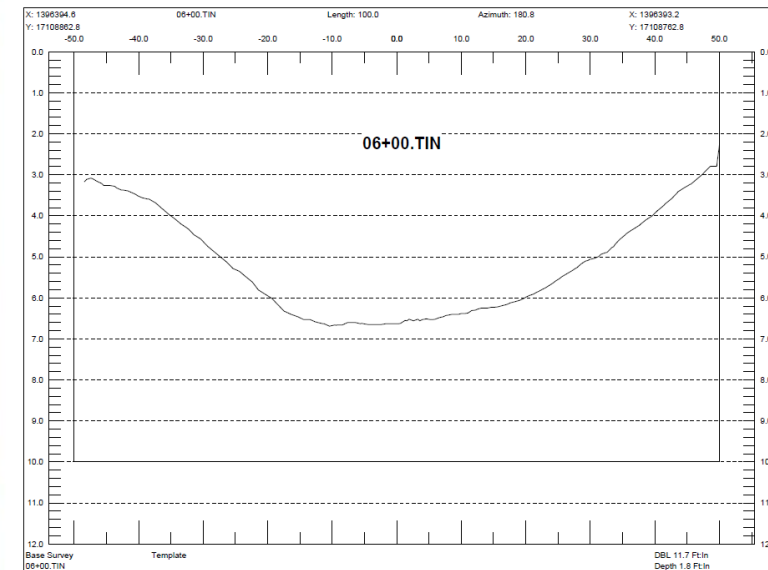
SHEET 2 of 2

Baseline of current water depths.

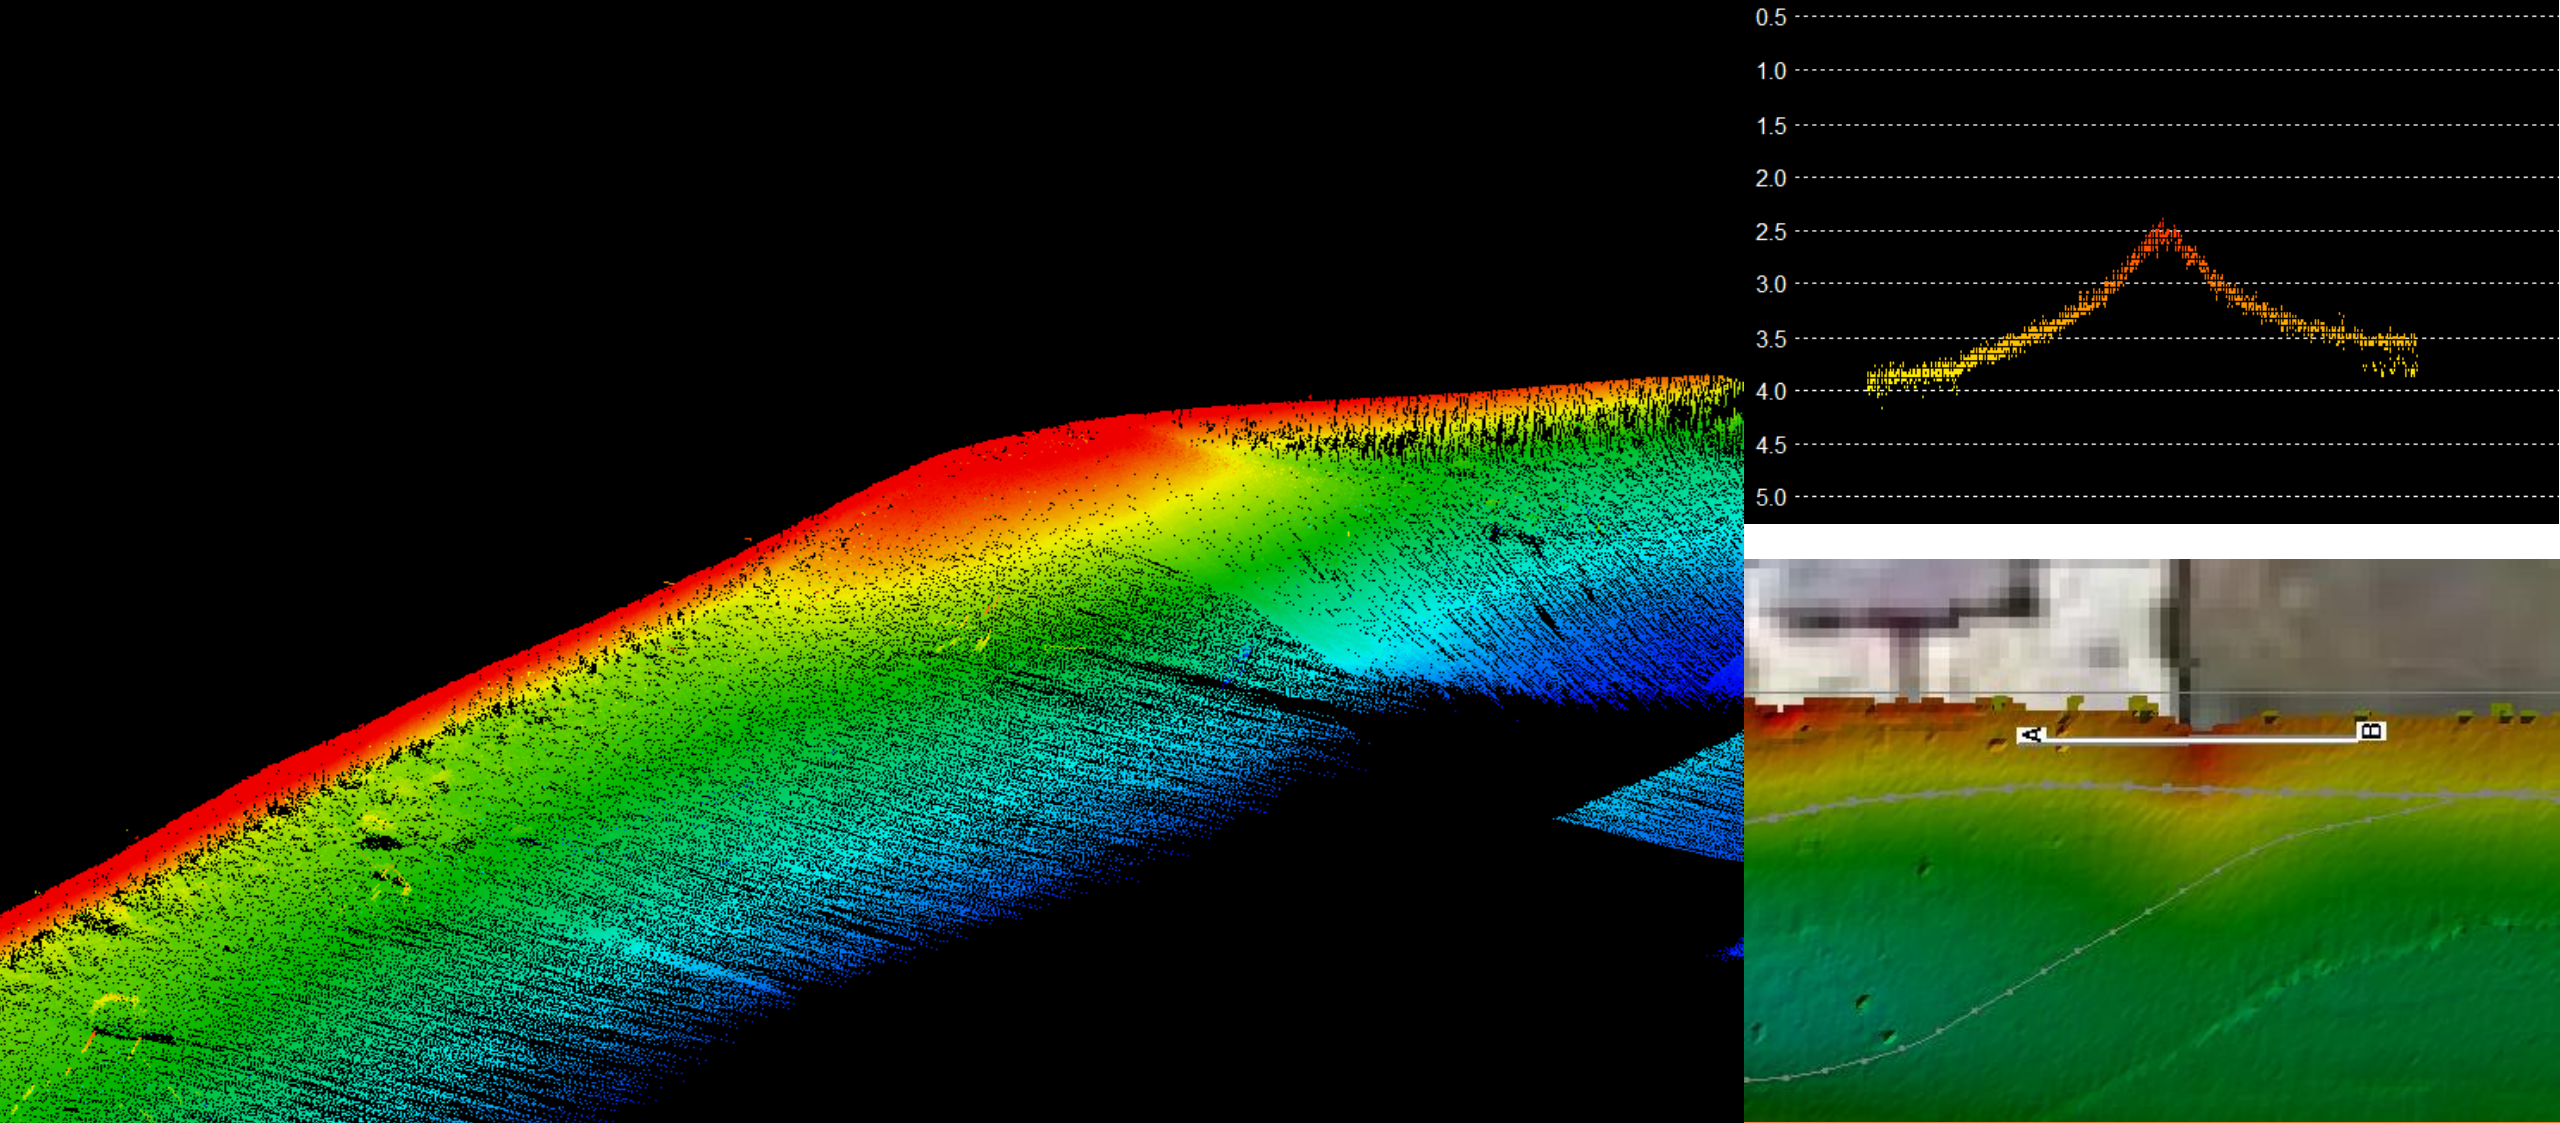
Sediment transportation into the canal system

Possible Bulkhead penetrations

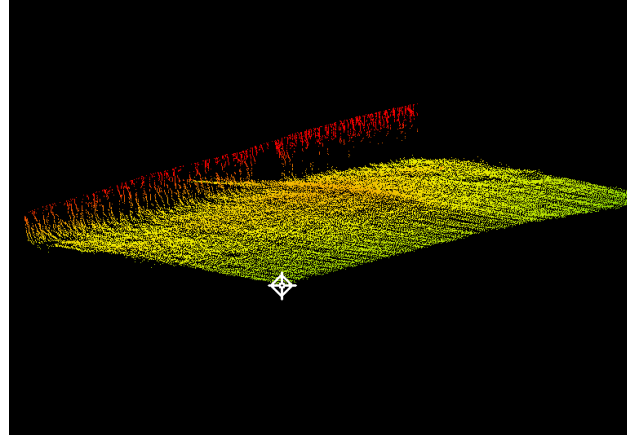
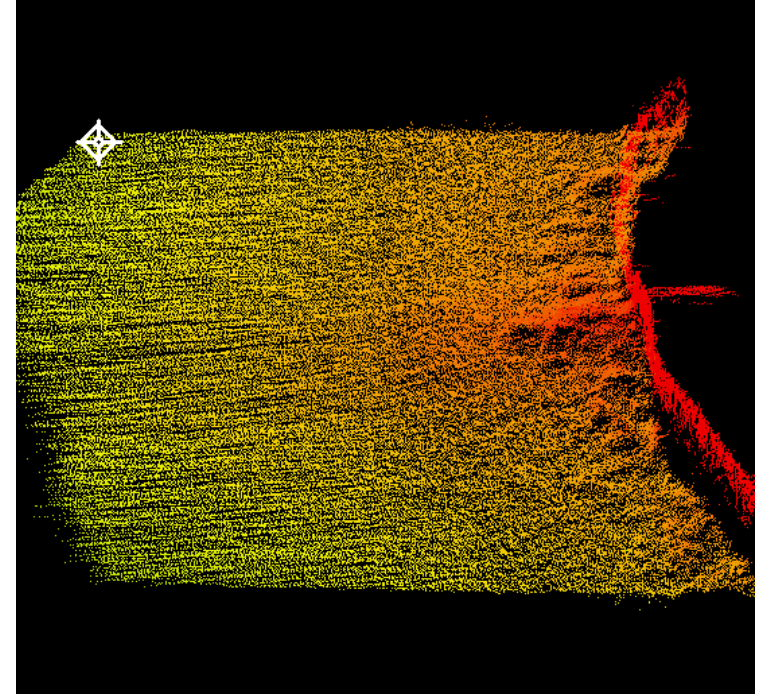
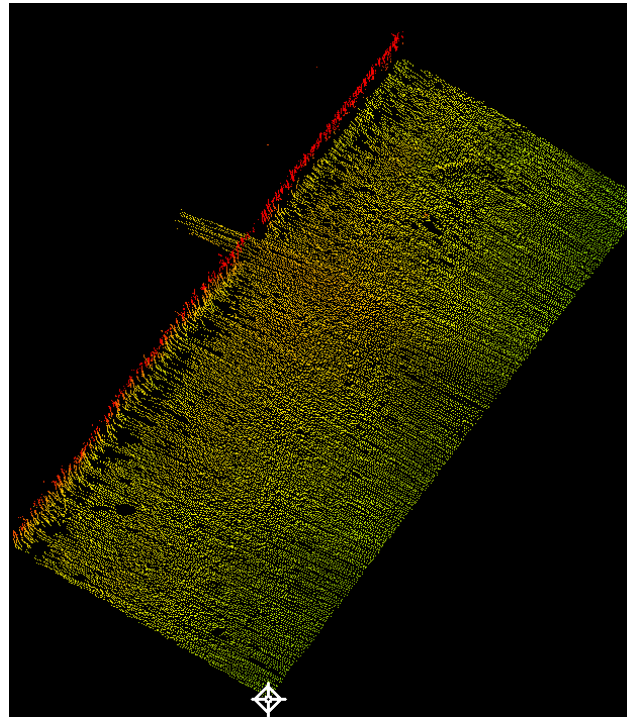
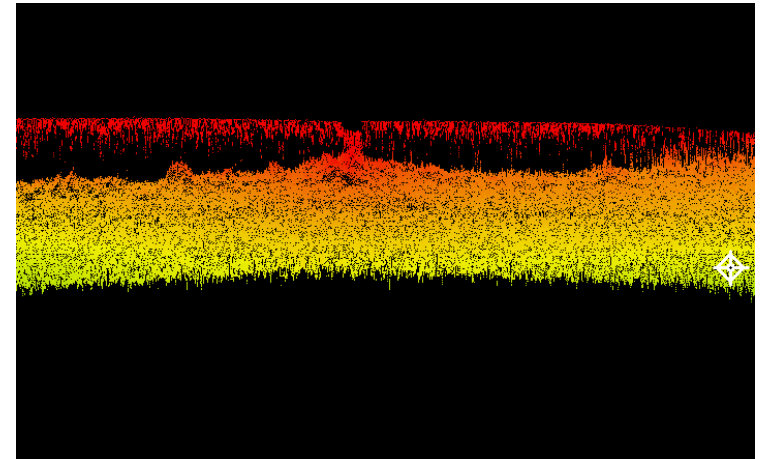
- Example of found hazards
- Dimensions
- 9'x5'x2'
